Title:
Environmental Audit for CIMERWA Plc

Environmental Audit report for CIMERWA PPC

Eco-Excellence Consultancy Ltd

April 2021

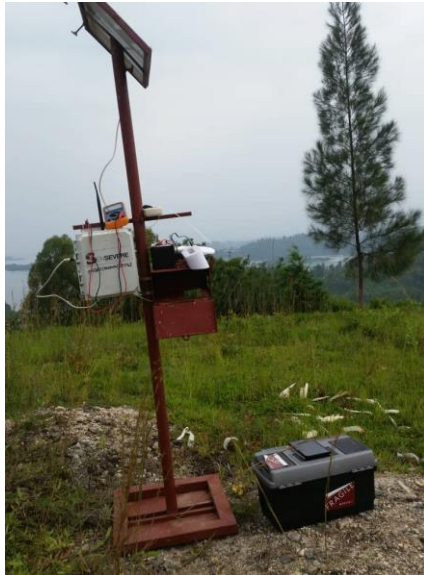
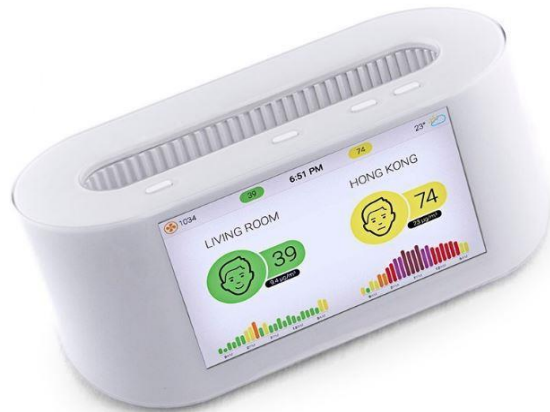
Figure 1: RAMPS sensor (left) and the AirVisual pro (right) used for air quality monitoring.

The Audit used Realtime Affordable Multipollutant sensors (RAMPS) with Met-One dust monitors (Figure 1) to measure ambient dust considering particles with aerodynamic diameter less than 2.5 micrometres (PM_{2.5}) and those with aerodynamic diameter less than 10 micrometres (PM₁₀). It also used AirVisual Pro. to complement RAMPS on dust monitoring.

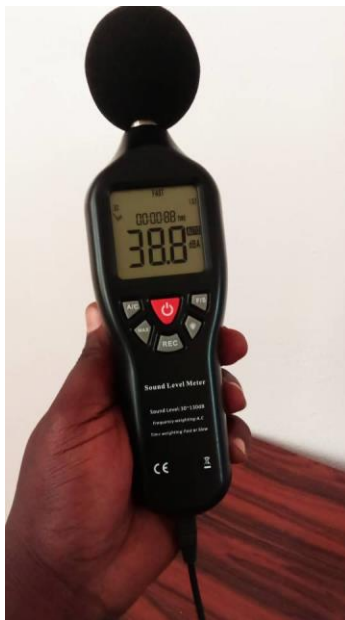
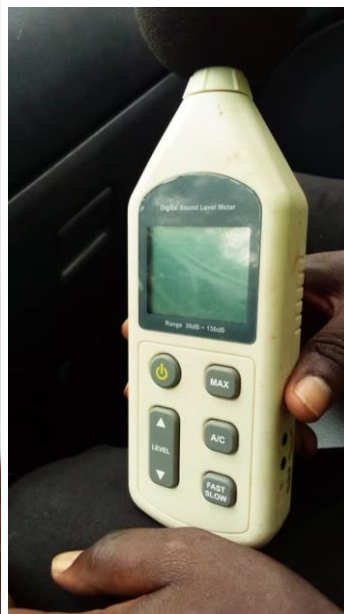
Figure 2: Sound level meters used for noise monitoring.

For noise monitoring, the Audit used digital sound level meters (Figure 2).

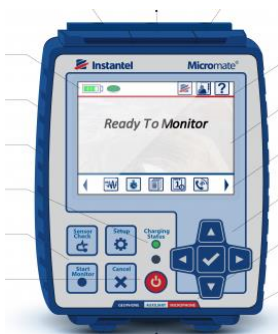
Figure 3: Instantel minimate used to monitor vibrations.

While for vibration monitoring, the Instantel Minimate (Figure 3) was used to measure the ground vibration.

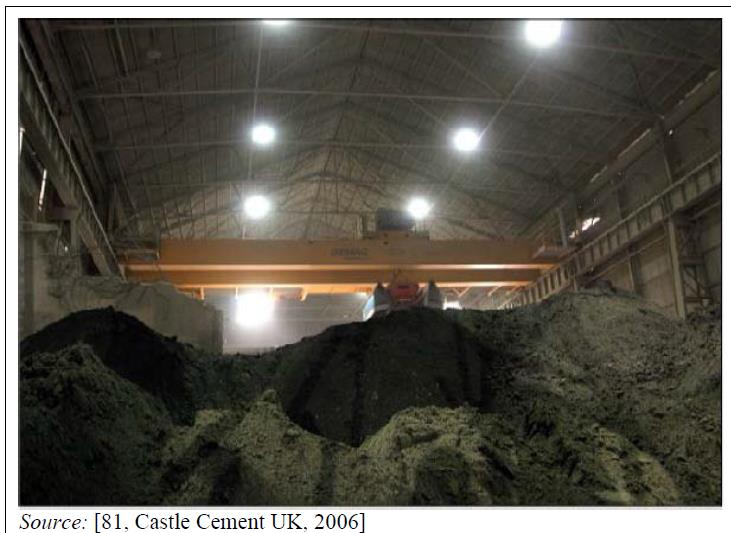
Figure 8: Example of covered raw material storage

(b) Raw material storage and preparation-Preparation of the raw materials is of great importance to the subsequent kiln system both in getting the chemistry of the raw feed right and in ensuring that the feed is sufficiently fine. The need to use covered storage depends on climatic conditions and the amount of fines in the raw material leaving the crushing plant.

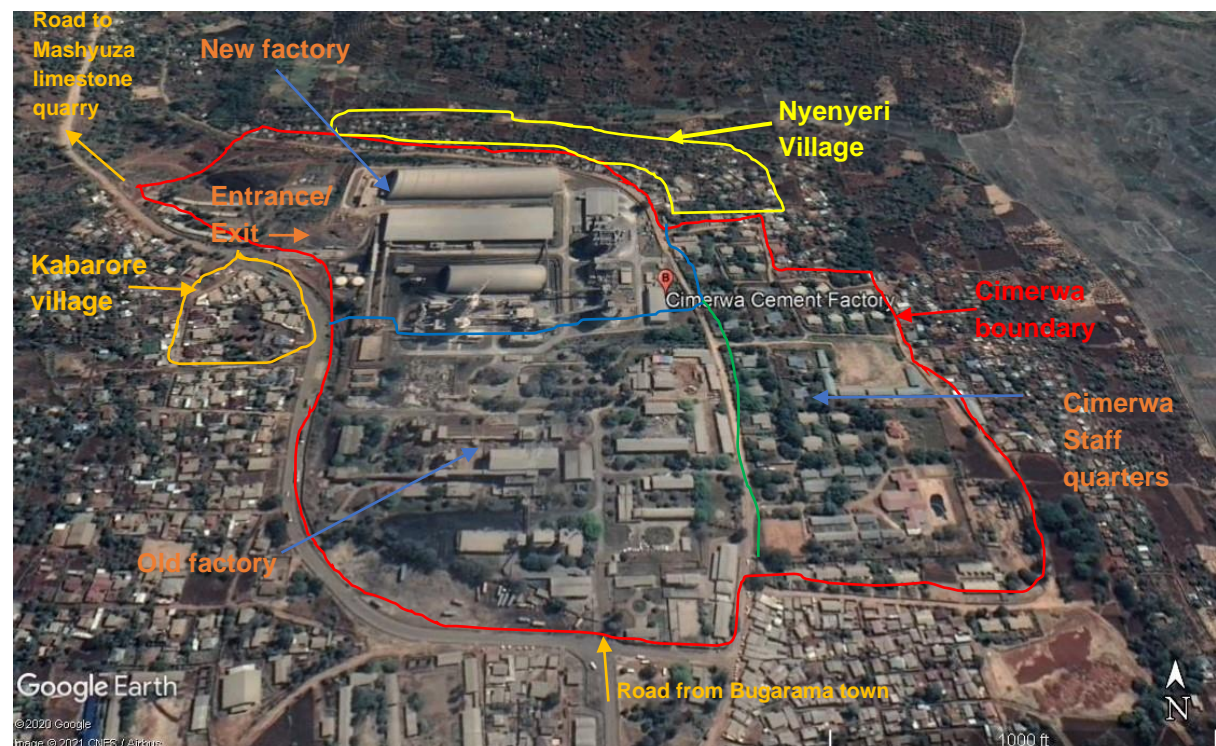
Figure 12: Cimerwa factory and its surrounding communities

It is located in Rusizi District, Muganza sector, Shara cell, Nyenyeri and Kabarore villages and surrounded mostly by residential communities from the two villages mentioned above and shown in the area layout below.

The quarry that supplies limestone to CIMERWA is located at 3 km to the North, at the location of Amashyuza hot springs. Also, along the unpaved road to Amashyuza quarry, within 1 km upslope of the road, are human settlements. Key vulnerable receptors of air pollution along the road are Mashsha health center located at about 600 m from the road and Mashsha primary school located at 1 km from the road. The highest population density along the road is located near the health center and the school.

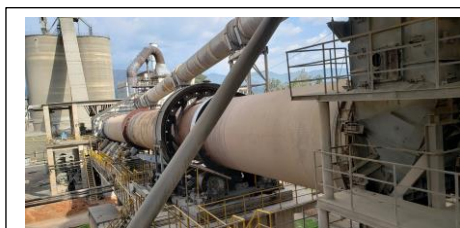
Rotary kiln

- e) Kiln stage- At the kiln, coal is the main fuel used to burn the pre-heated raw meal at a temperature of 1500°C to produce Clinker. Clinker is then cooled at the cooler from 1500°C to 250°C, giving off hot air recycled for re-use at the pre-heater cyclones of the previous pre-heating stage. Cooled clinker is stored in silos. Cimerwa is currently using locally available alternative fuels to minimise use of coal, such as; peat, rice husks and palm kennel. The target is to have about 19% use of alternative fuels replacing coal use but are currently at 13%.

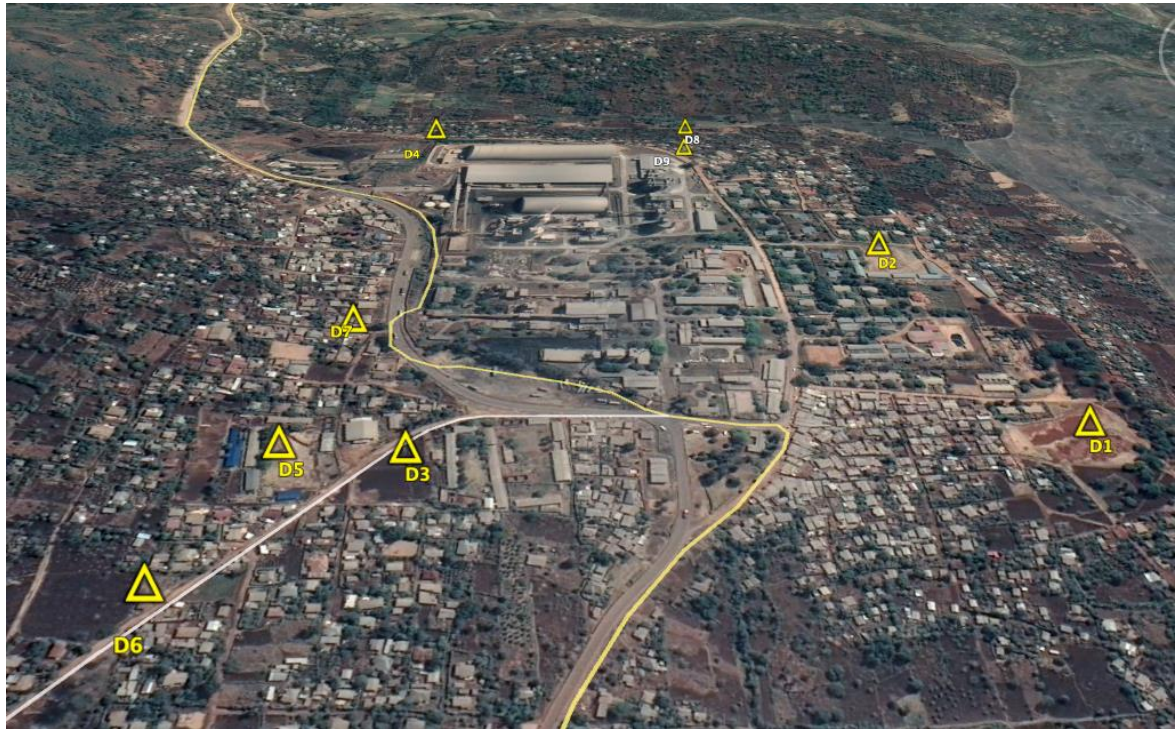
Ambient level of PM_{10} and $PM_{2.5}$ has been monitored at nine different locations around the factory. The sites are shown in the figure 14.

Figure 14: Location of sites (D1 --- D9) that were used for dust monitoring.

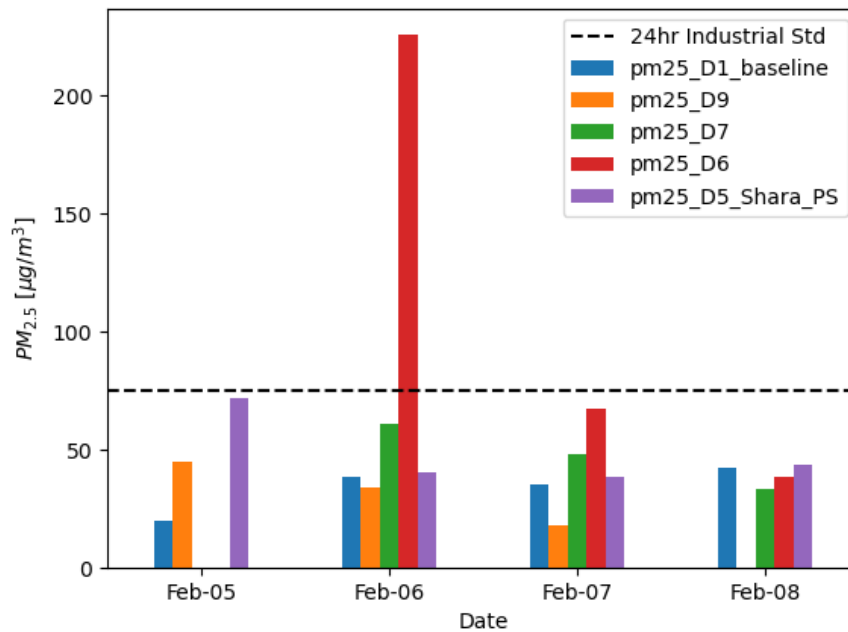
Figure 15 below shows that $PM_{2.5}$ levels were below the maximum limit except for Sunday February 6th, where the site D6 was significantly higher than the standard limit. The site D6 is located 500 m away from CIMERWA on the road passing by the Shara primary school. The possible explanation for high $PM_{2.5}$ levels at D6 is that it is at a higher elevation uphill compared to the Cimerwa chimney heights and therefore the most susceptible site to $PM_{2.5}$ dust particles that are a lighter than PM_{10} and carried longer distances by wind.

Figure 15: Ambient levels of $PM_{2.5}$ at four different locations compared to standards.

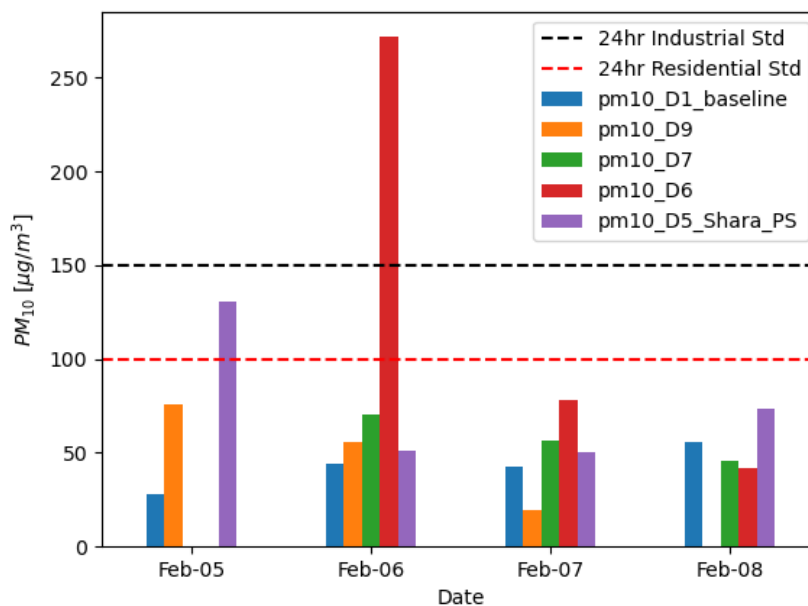
Figure 16 indicates that large particles (PM_{10}) violated the ambient standard limit on February 5th, and February 6th for D5 and D6 respectively. The two locations are close to each other, D5 being the Shara primary school which is located at 300 m from the factory.

Figure 16: Ambient levels of PM_{10} compared to standards.

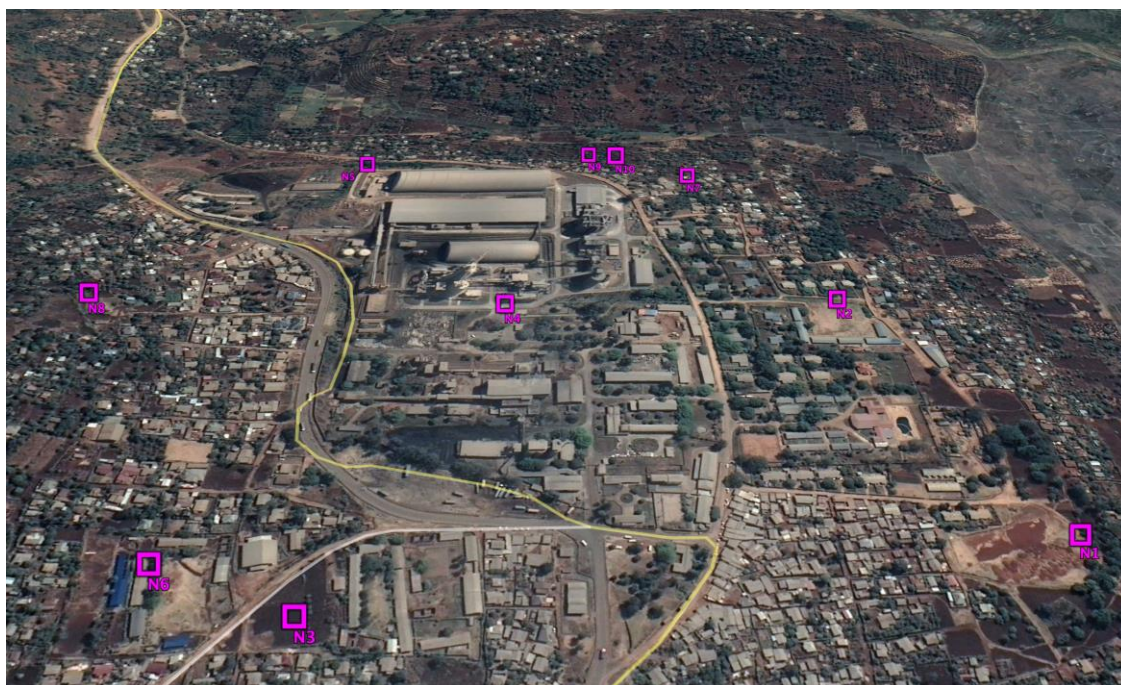
Figure 33: Sites that were used for ambient noise monitoring.

Noise levels have been monitored at eight different sites during days and nights. The sites that were used for noise monitoring are presented in figure 33 below.

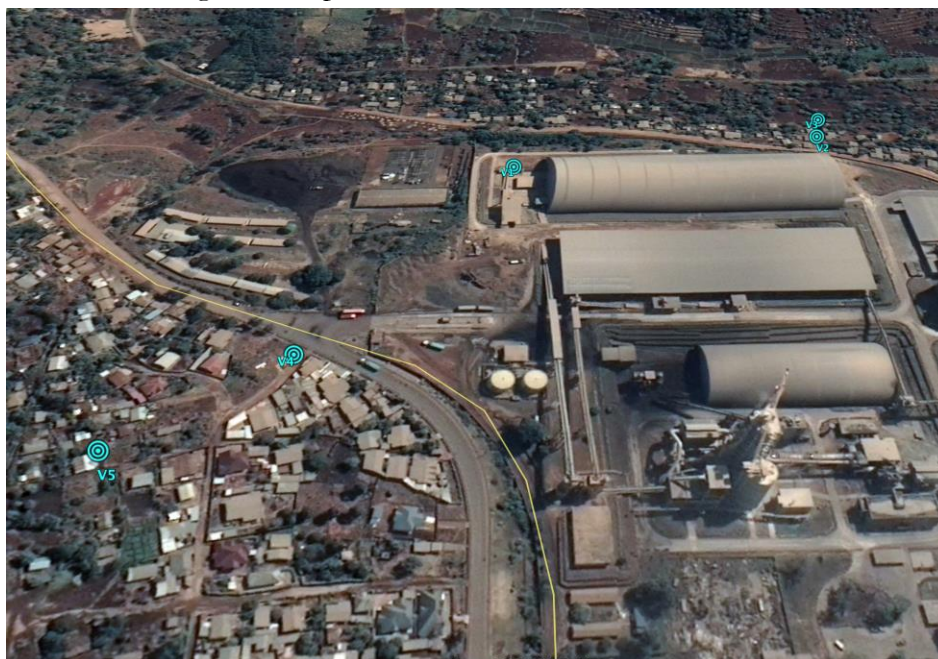
Figure 51: Vibration monitoring sites “V1 to V5”.

Ground vibration were monitored at five locations as highlighted in figure 51. The measure peak particle velocities (PPV) are presented in figure 52 below. The highest PPV were obtained inside the factory near the main crusher site which was still below the set standard of 5mm/s. However, these vibration measurements were taken when the mobile crusher was not operating which is expected to be the one responsible for most ground vibrations. As discussed in section 3.3.3, vibration is dampened quickly near the source. Consequently, the lack of vibration data resulting from operation of the mobile crusher may affect the findings on residents directly adjacent to the factory but would not inform recommendations of the buffer distance to mitigate its impact.

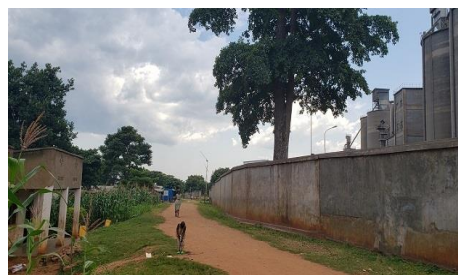
Proximity of factory to Nyenyeri residences

- First of all, the issue of zoning of the area between Industrial and residential needs to be discussed and resolved by Rusizi District. This will rectify the compliance requirements of the factory from residential to only Industrial standard requirements and minimize the increment in settlements closer to the factory.
- Basing mainly on Cimerwa's non-compliance towards residential standards as per its current area zoning, it is recommended that a buffer zone be established between the factory and closest resident that is at least 500 m from the Industry chimney by relocating those within this 500m radius, based on the recommendation of 500m from

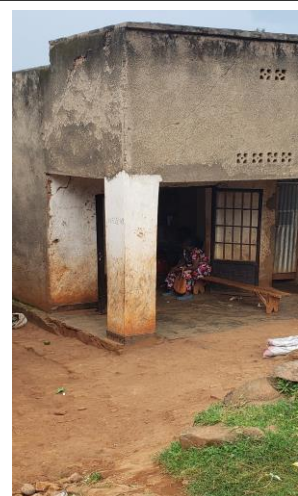
Cracks on house in Nyenyeri claimed to be a vibration effect.

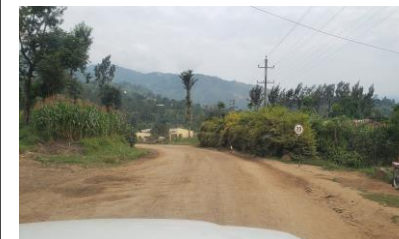
Speed limits to reduce on accidents and raising dust by trucks on the Amashyuza quarry road.

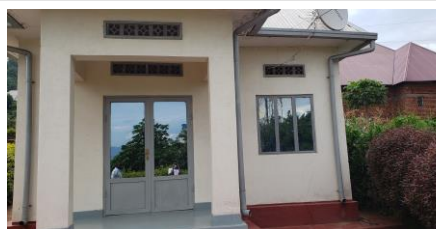
Cracks on house in Kabarore claimed to be a vibration effect.

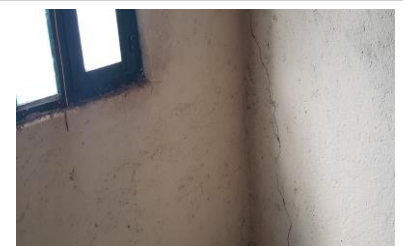
Cracks in house in Nyenyeri claimed to be a vibration effect.
